# Manhole Inspection Summary

## Manhole # S13GG1029MH

Insp Date: **7/11/08 12:16 PM**

**Location** Address: **4200 PARK HEIGHTS AVE** Cross Street: **QUANTICO AVE**

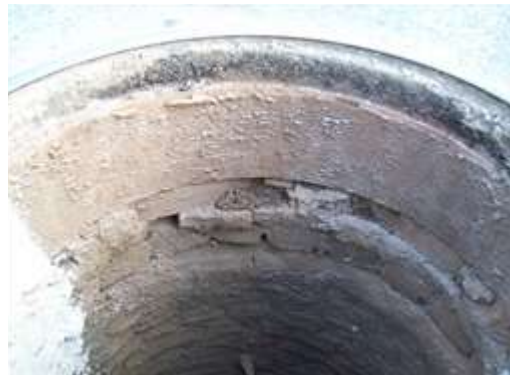
Defect 2

Condition: ☐ Sound ☐ Cracked ☐ Root Intrusion ☐ Loose Brick ☒ **Deteriorated**

DETERIORATED CHIMNEY

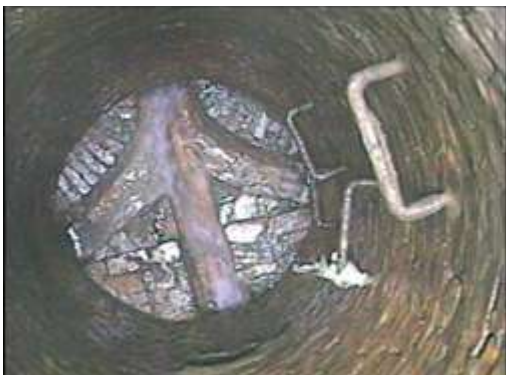
Defect 1

**Surcharge** ☒ **Evidence Of Surcharge** Depth: **7** (ft.) ☐ Active Surcharge Present

EVIDENCE OF SURCHARGE

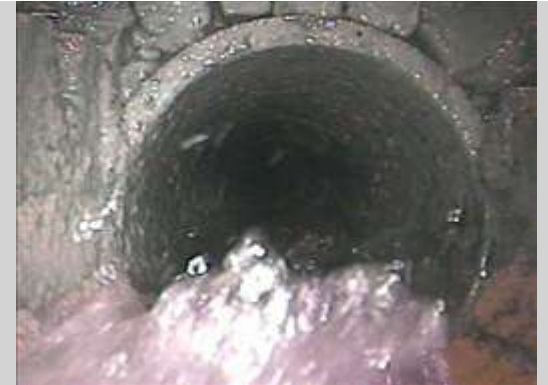
12 O'Clock Outflow

10 in. Circular Gravity Sewer  
Pipe Out @ 12 O'Clock

Pipe Height: (in.) Direct  
Pipe Material: **Clay** ☐ Pipe Lined  
Invert Depth: **12.58** (ft.) Flow Characteristics: **Fast**  
Deposits: ☒ None ☐ Mud ☐ Sludge ☐ Debris ☐ Grease  
Silt Depth: (in.) Deposits Extent:  
Infiltration: **None** Pipe Seal Cond: **Sound**

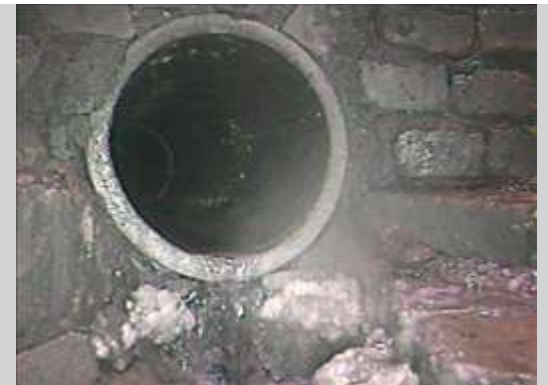
3 O'Clock Inflow

8 in. Circular Gravity Sewer  
Pipe In @ 3 O'Clock

Pipe Height: (in.) Direct  
Pipe Material: **Clay** ☐ Pipe Lined  
Invert Depth: **12.46** (ft.) Flow Characteristics: **Slow**  
Deposits: ☒ None ☐ Mud ☐ Sludge ☐ Debris ☐ Grease  
Silt Depth: (in.) Deposits Extent:  
Infiltration: **None** Pipe Seal Cond: **Sound**

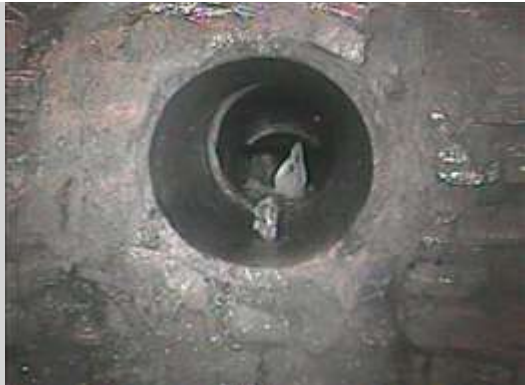
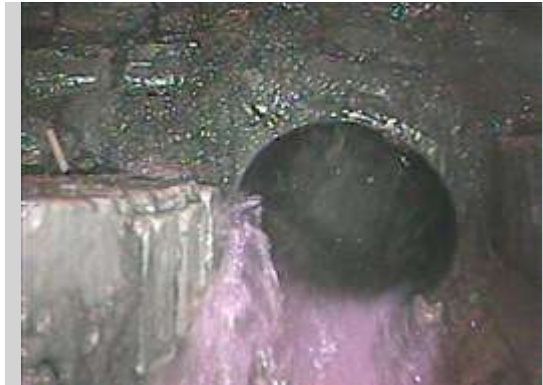
6 O'Clock Inflow

8 in. Circular Gravity Sewer

Pipe In @ 6 O'Clock

Drop In @ 6 O'Clock

Drop: **Outside Direct**

Drop Condition: **Open**

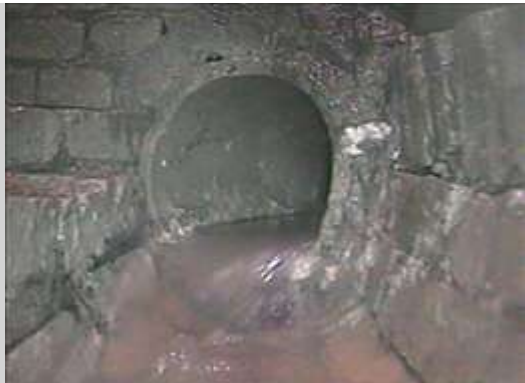
9 O'Clock Inflow

8 in. Circular Gravity Sewer

Pipe In @ 9 O'Clock

Infiltration: **None** Pipe Seal Cond: **Sound**
